**Situational Quality Report on the Estates Division of the CSIR Food  
Research Institute**

**Technical Report**  
**CSIR-FRI/RE/A-OA/2015/002**

**July, 2015**

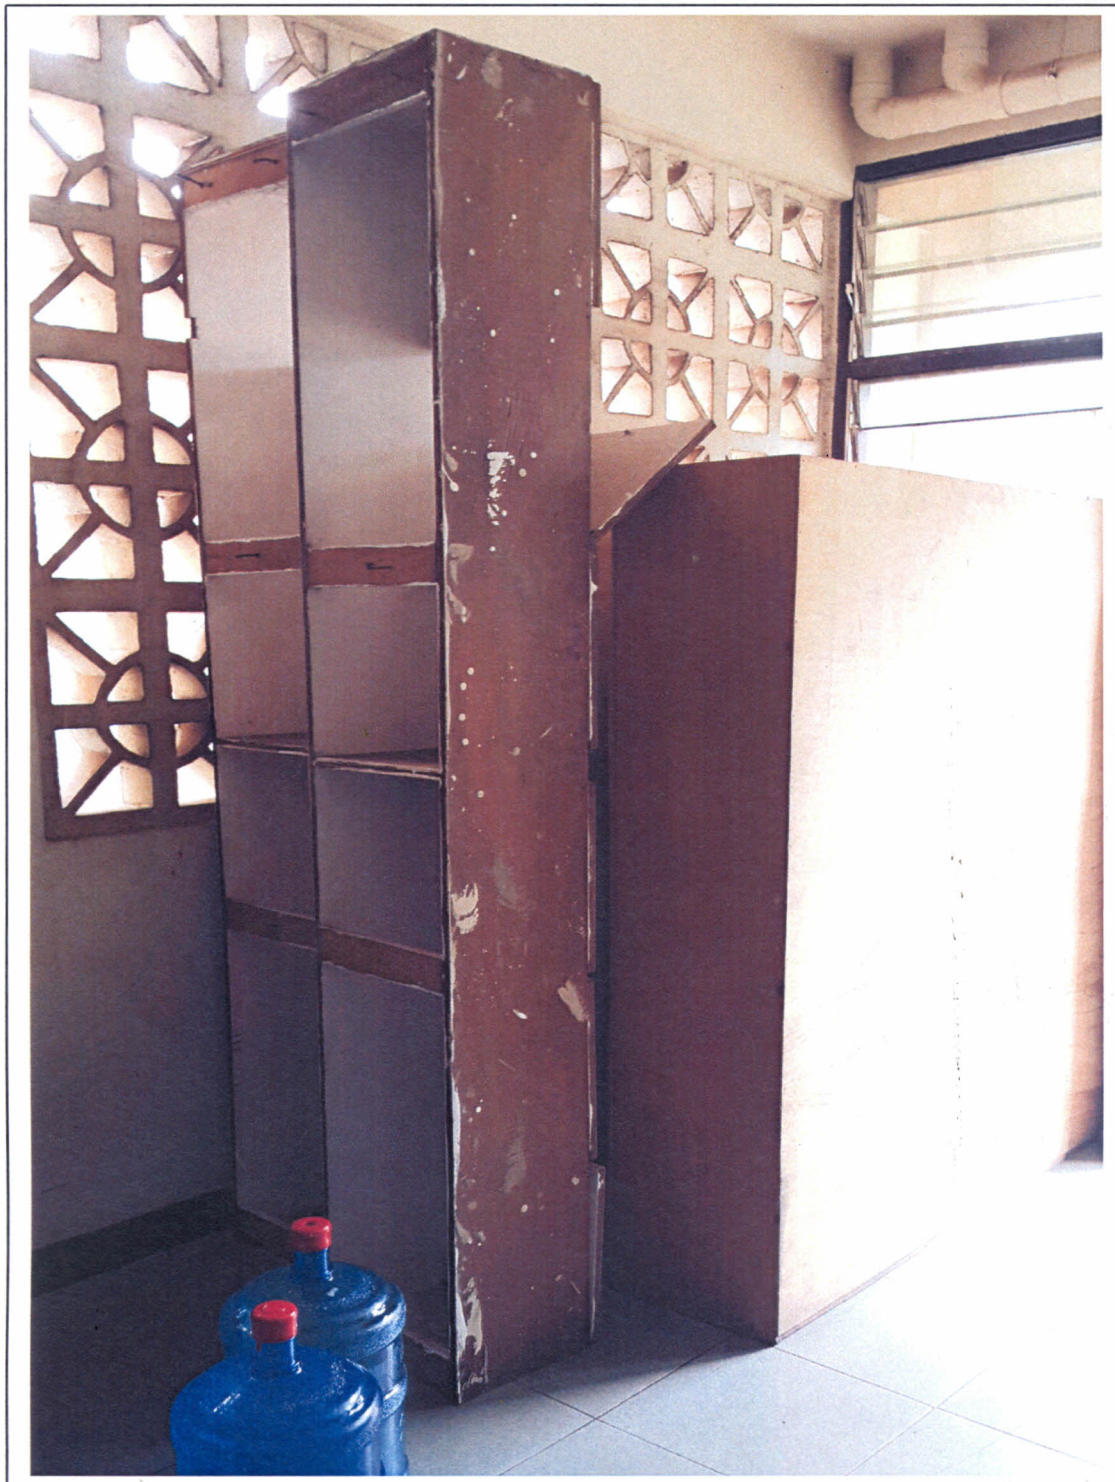
<p>Cupboards and Equipment</p> <ul style="list-style-type: none"> <li>Cupboards and equipment underneath and or by the staircases and in the passage ways need to be removed (See Fig. 1).</li> <li>Blocking of emergency exits with boxes (See Fig. 9).</li> </ul>	<ul style="list-style-type: none"> <li>These are obstructions to movement of staff, visitors and equipment and need to be removed.</li> <li>In case of an emergency, obstructions at the doorways would make evacuation difficult.</li> </ul>
<p>Key to Main Electrical Switch</p> <ul style="list-style-type: none"> <li>Main Electrical Switch on ground floor cannot be accessed because key cannot be found.</li> <li>Electrical Switch cupboards are used as storage for other materials. These could be inflammable in case of accidental electrical sparks (See Fig. 7 &amp; 8).</li> </ul>	<ul style="list-style-type: none"> <li>Key should be replaced.</li> <li>The Electrical Switch Cupboards should be emptied of all materials.</li> </ul>

Fig. 1. A Picture Showing Cupboards Left Near Back Entrance Door To The Main Building

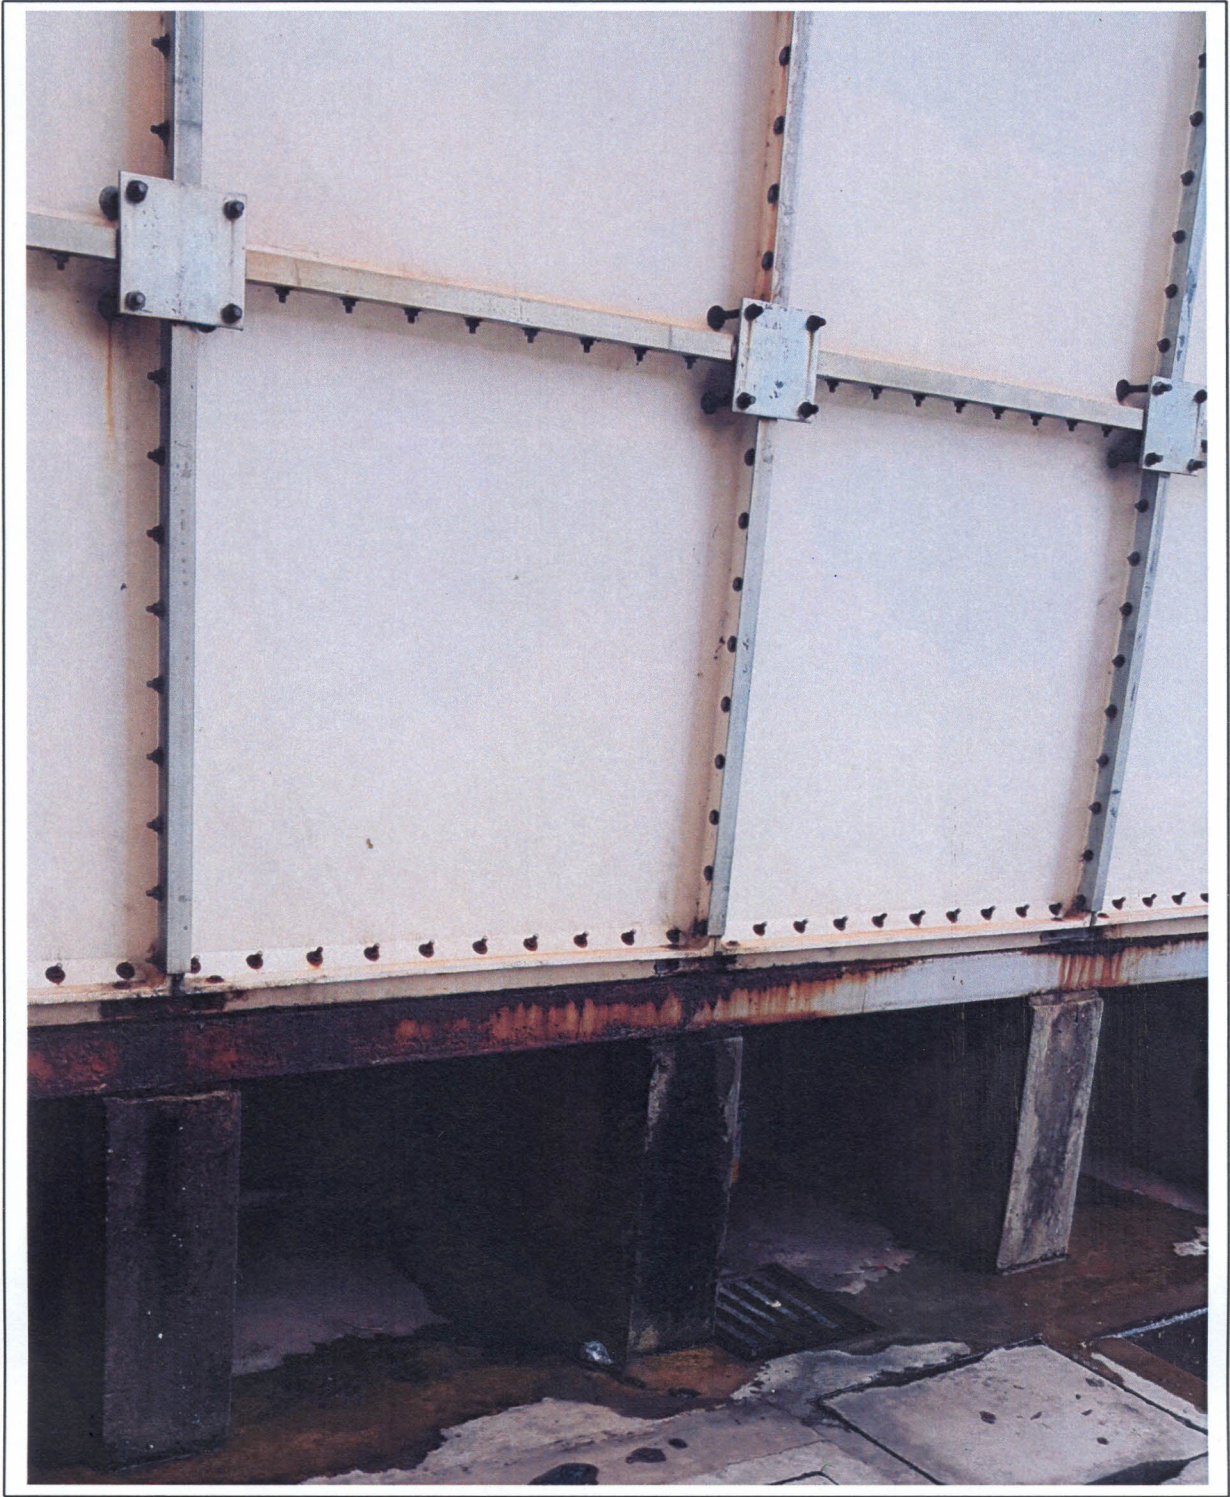
Fig. 2. Leaking Water Tank Behind the Main Building

<p>Allocation of Visitor Toilet</p> <ul style="list-style-type: none"> <li>• Head of Estate's Unit, proposes that one of the ground floor toilet's is permanently allocated to Visitors. This would be stocked with enough toilet paper, adequate soap, air re-fresher and well maintained. The place would be locked and a copy of the key kept with the Receptionist.</li> </ul>	<ul style="list-style-type: none"> <li>• This laudable idea should be implemented to maintain standards.</li> <li>• A copy of the key to the other toilet that has been permanently locked but used by a few female staff members should be made available to other female staff on the floor.</li> </ul>
<p>Institute's Grounds</p> <ul style="list-style-type: none"> <li>• Weeds still on pavement although weedicide has been applied.</li> <li>• Clearing of area behind the Mushroom Unit and Engineering (See Fig. 3).</li> <li>• Leaking of Water Tank serving the Main Building (see Fig. 2)</li> </ul>	<ul style="list-style-type: none"> <li>• Weeds should be plucked out in addition to the application of weedicides as the weedicide treatment does not seem effective.</li> <li>• Leaking Water Tank must be repaired.</li> </ul>

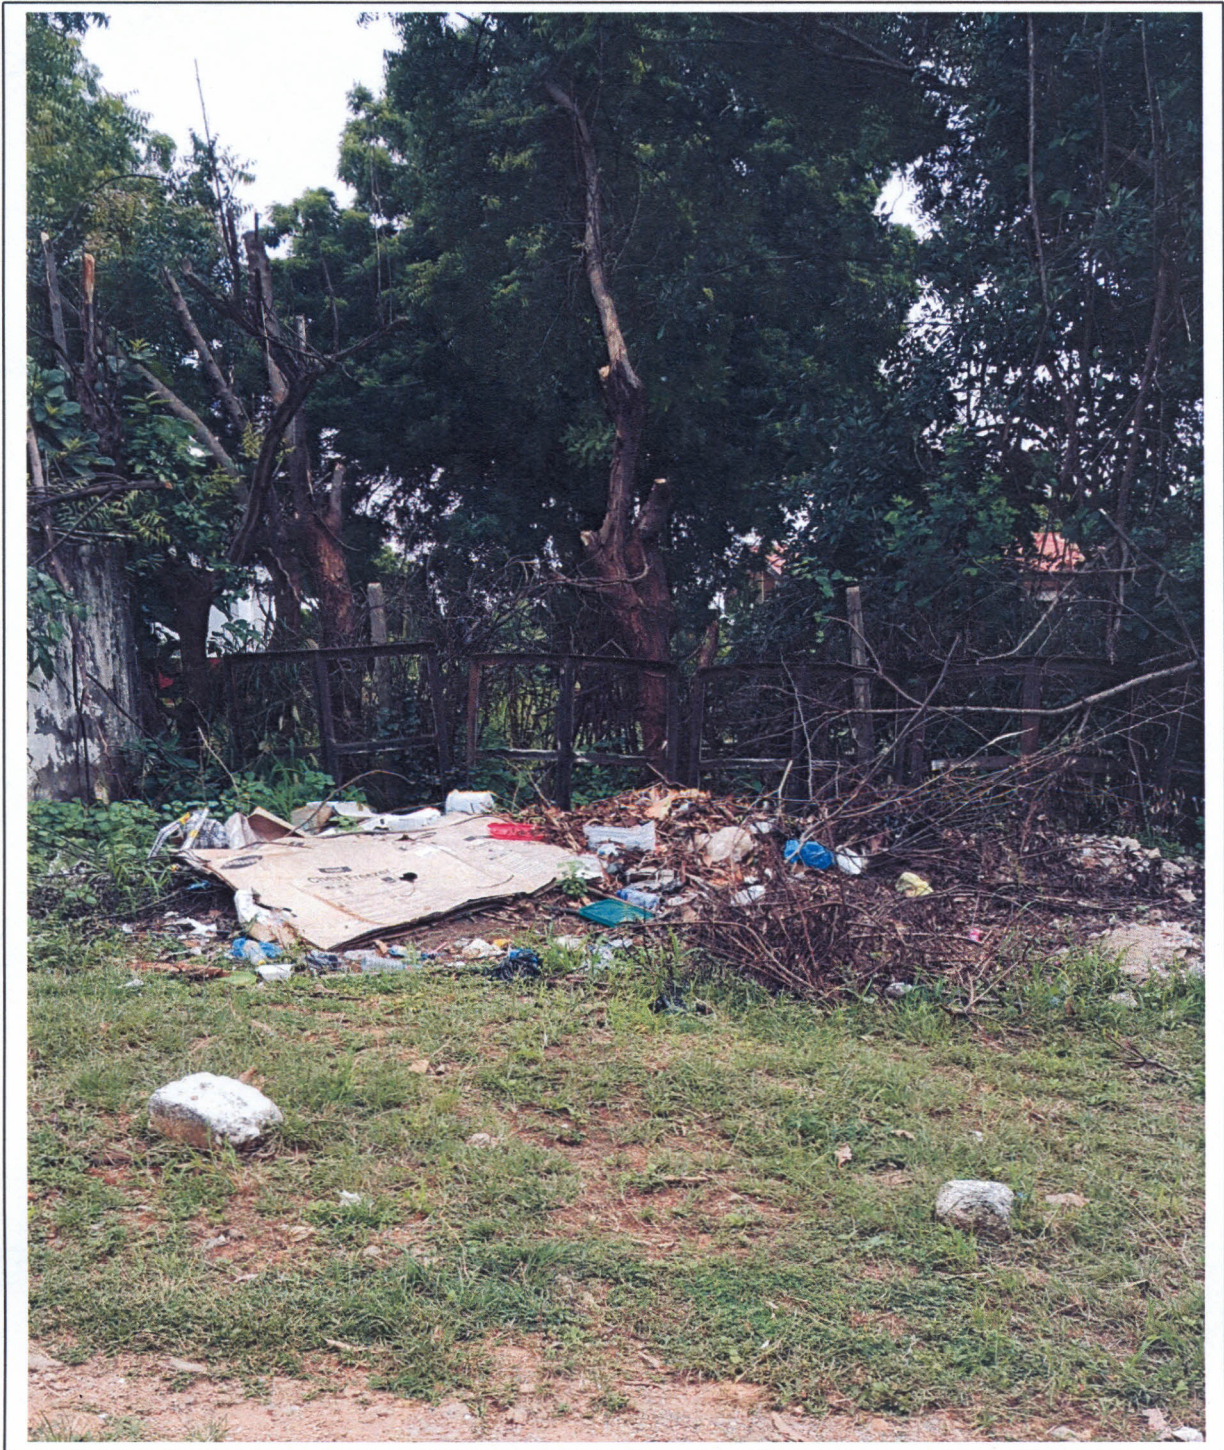
Fig. 3 Refuse dumped on grounds behind Mushroom Unit

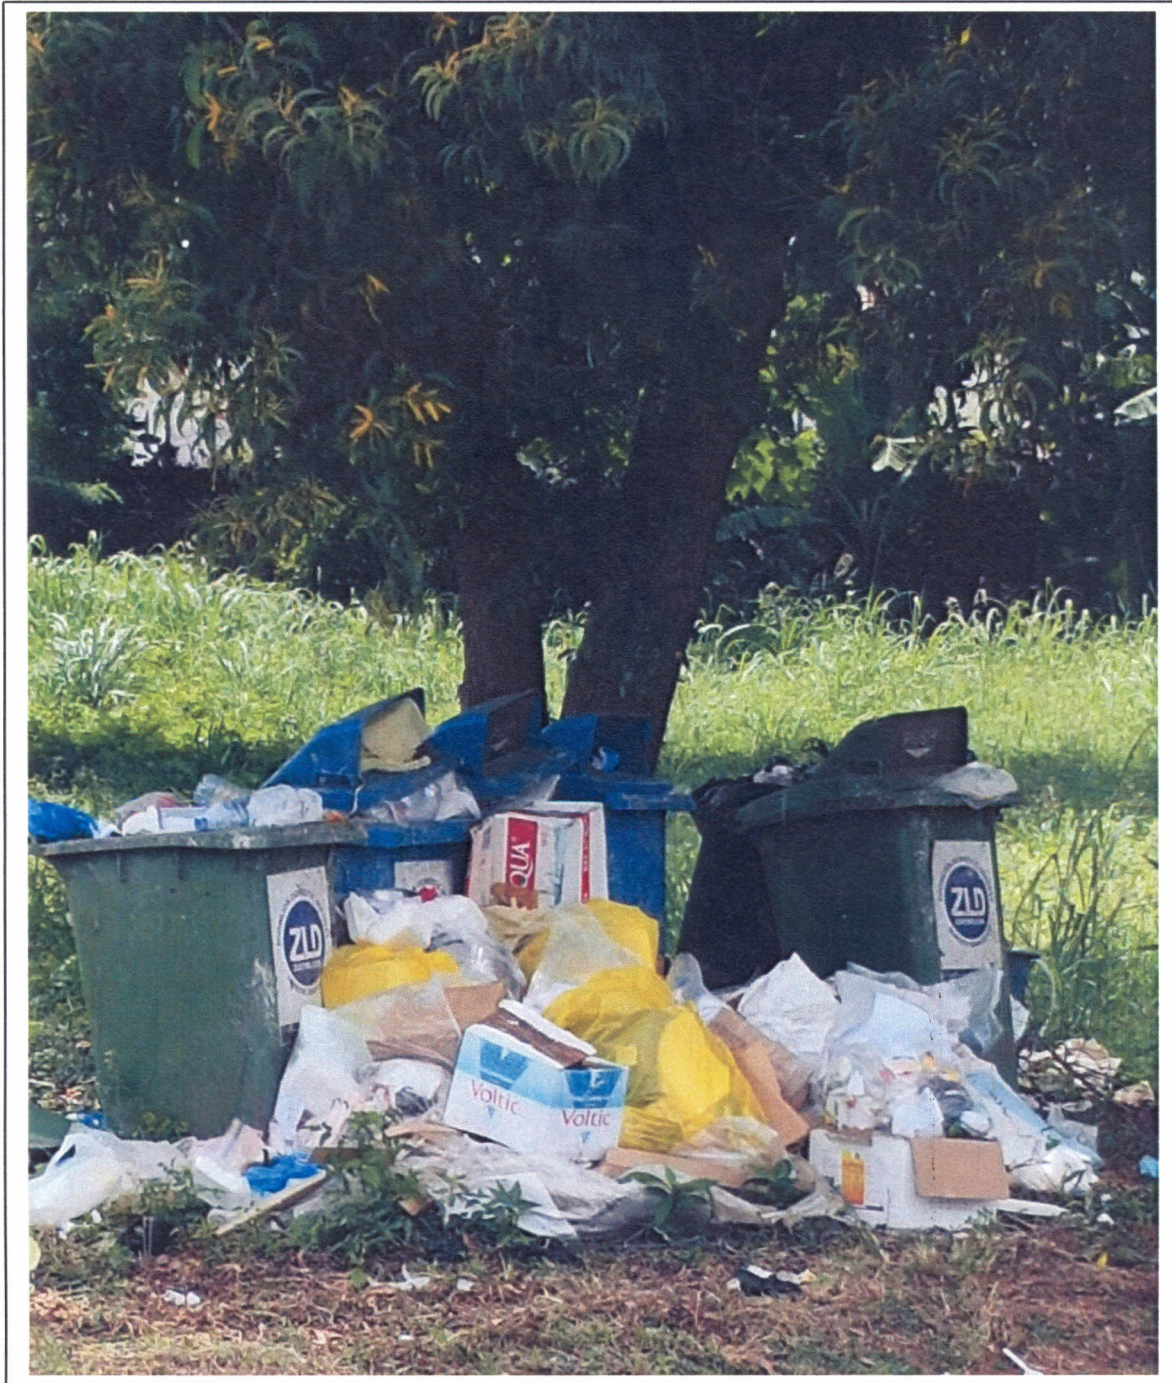
Fig. 4. Refuse Awaiting Collection from Institute Grounds

<p>Refuse</p> <ul style="list-style-type: none"> <li>• The new company contracted to dispose of refuse comes once in a week. Additional day of collecting refuse will attract additional charges.</li> </ul>	<ul style="list-style-type: none"> <li>• The refuse should be collected at least twice a week. Also effort should be made at providing bigger bins so that refuse can be sorted into plastics, paper or cardboard and domestic waste. Paper and cardboard waste are collected free of charge by some paper processing companies and that would save the Institute some money on waste disposal.</li> <li>• A permanent preferably half walled Refuse Storage Area, to keep the grounds tidy as the current point for collection is an eye sore and could allow pests to easily access the processing area (See Fig. 4).</li> </ul>
<p>Washrooms</p> <ul style="list-style-type: none"> <li>• Packaging cards / boxes and newspaper are used as toilet paper in some toilets.</li> <li>• Unavailability of soap for handwashing.</li> <li>• Sanitary pads not disposed of properly.</li> </ul>	<ul style="list-style-type: none"> <li>• Consistent provision of toilet paper for staff use as a matter of urgency.</li> <li>• Installation of lockable toilet roll dispensers.</li> <li>• Provision of waste bins purposely for</li> </ul>

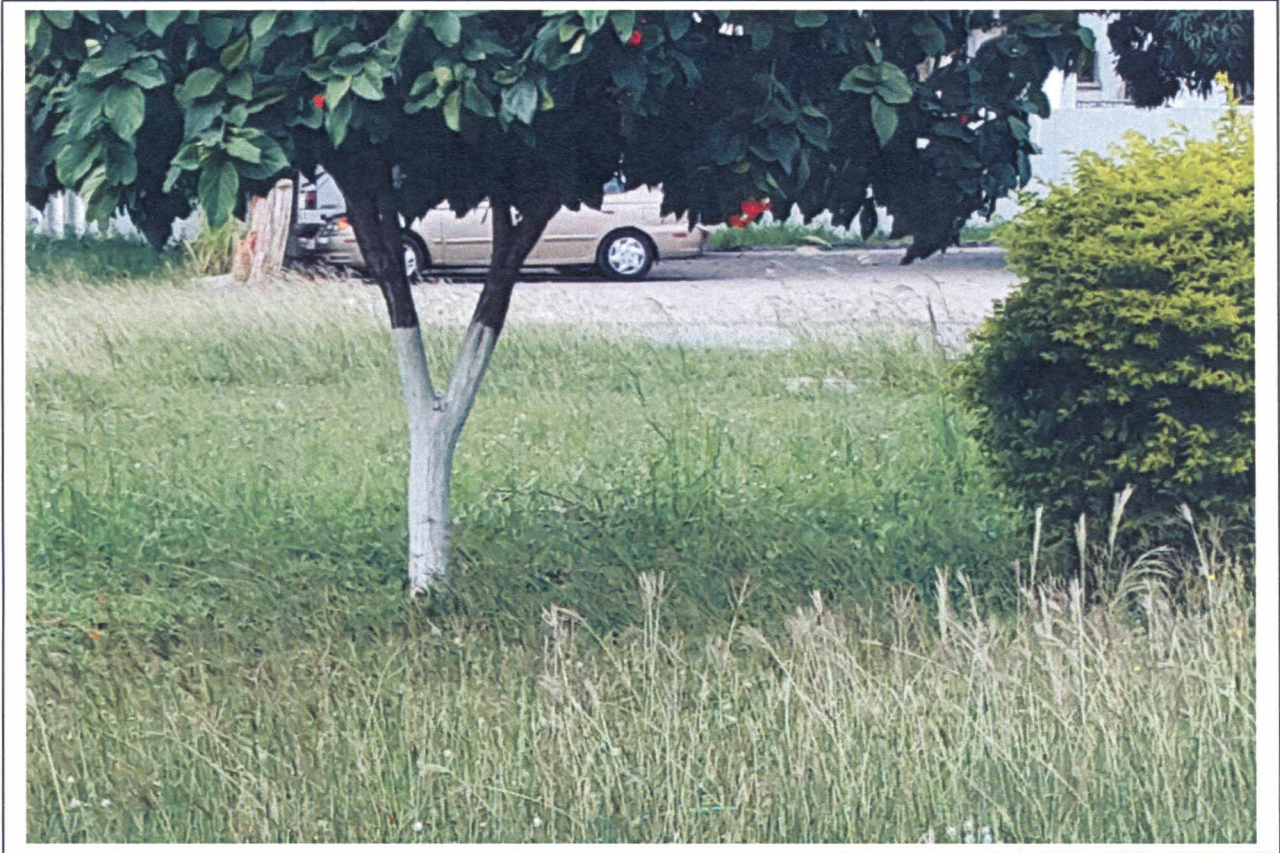
Fig. 5. Overgrown Grass on Institute Lawns

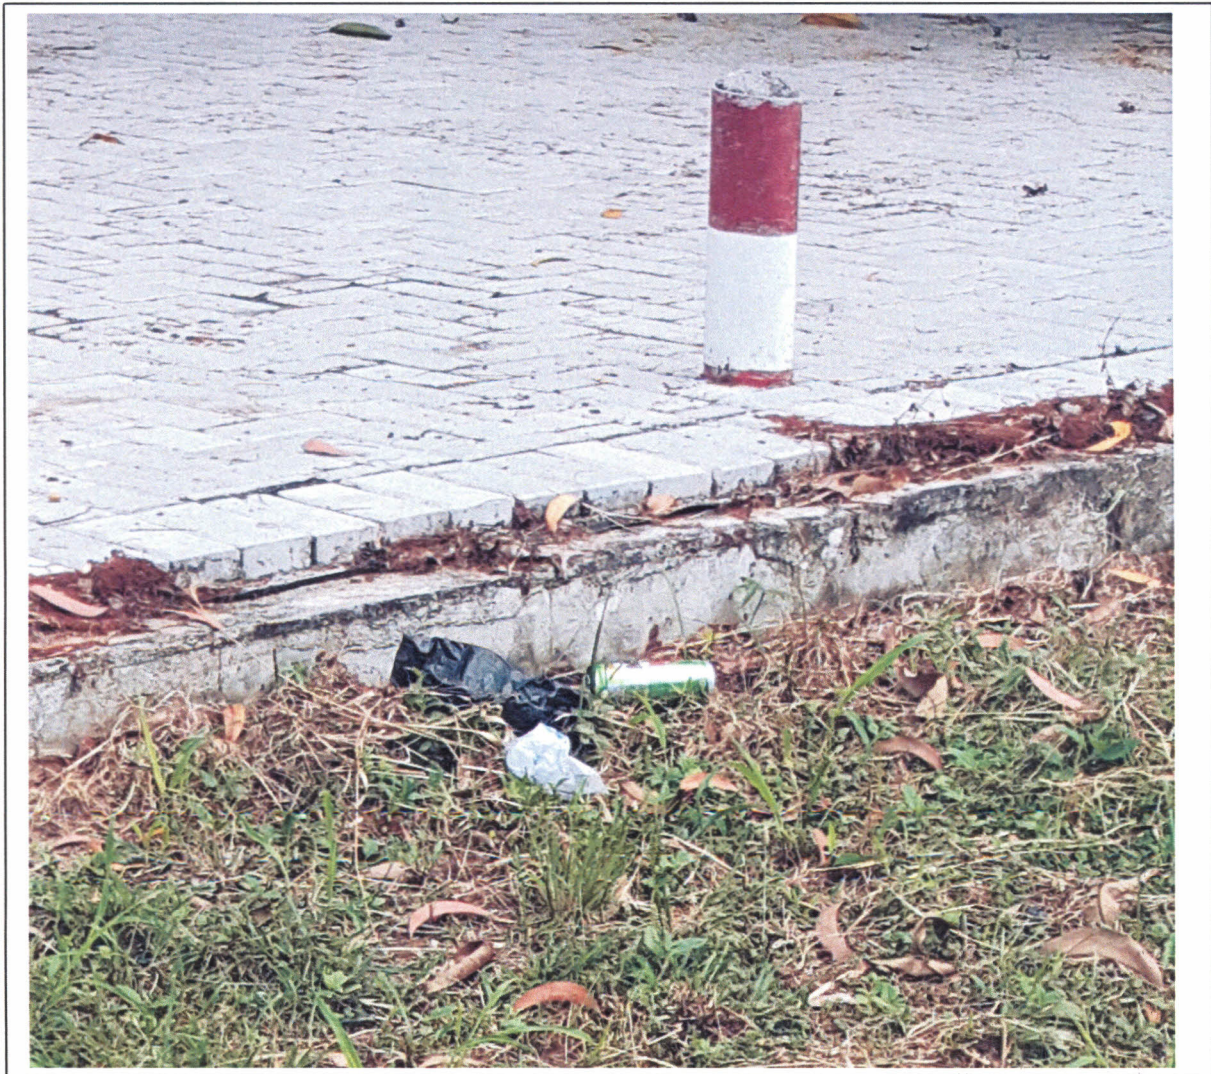
Fig. 6 Picture Showing Litter on Green Grass / Lawns

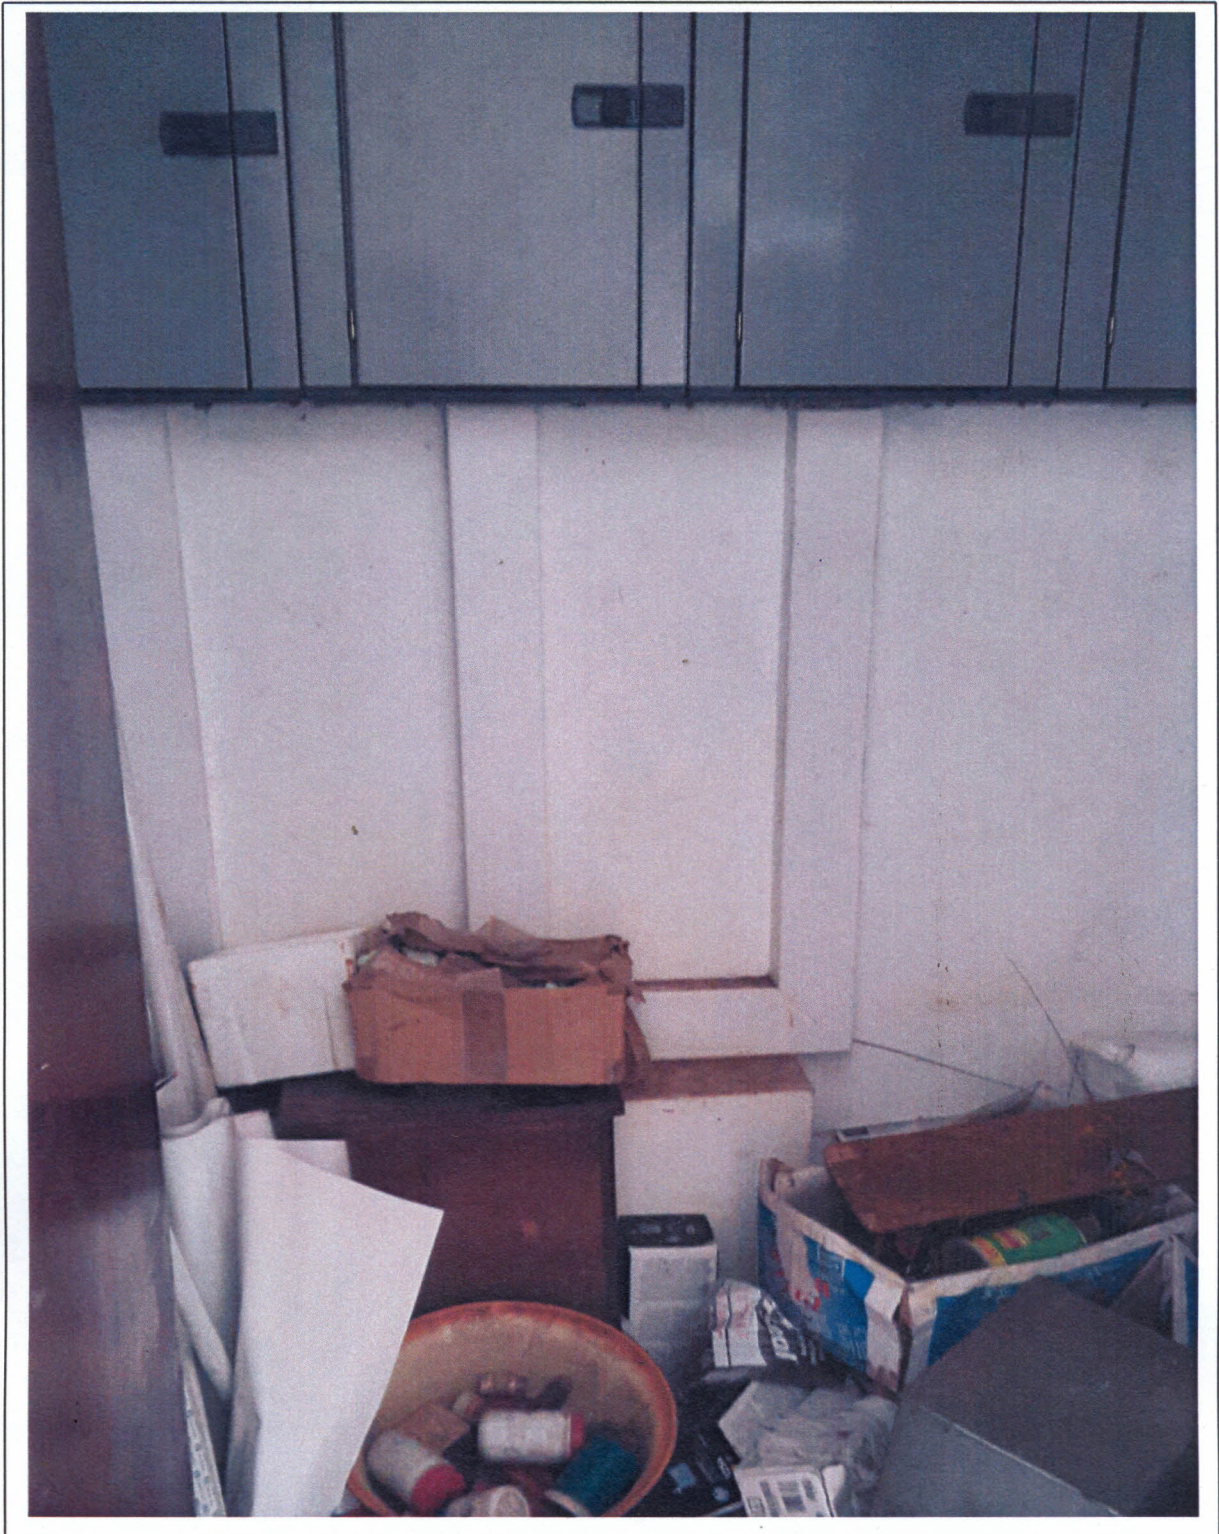
Fig. 7 . Electrical Switch Cupboards Being Used As Storage of Potentially Flammable Material

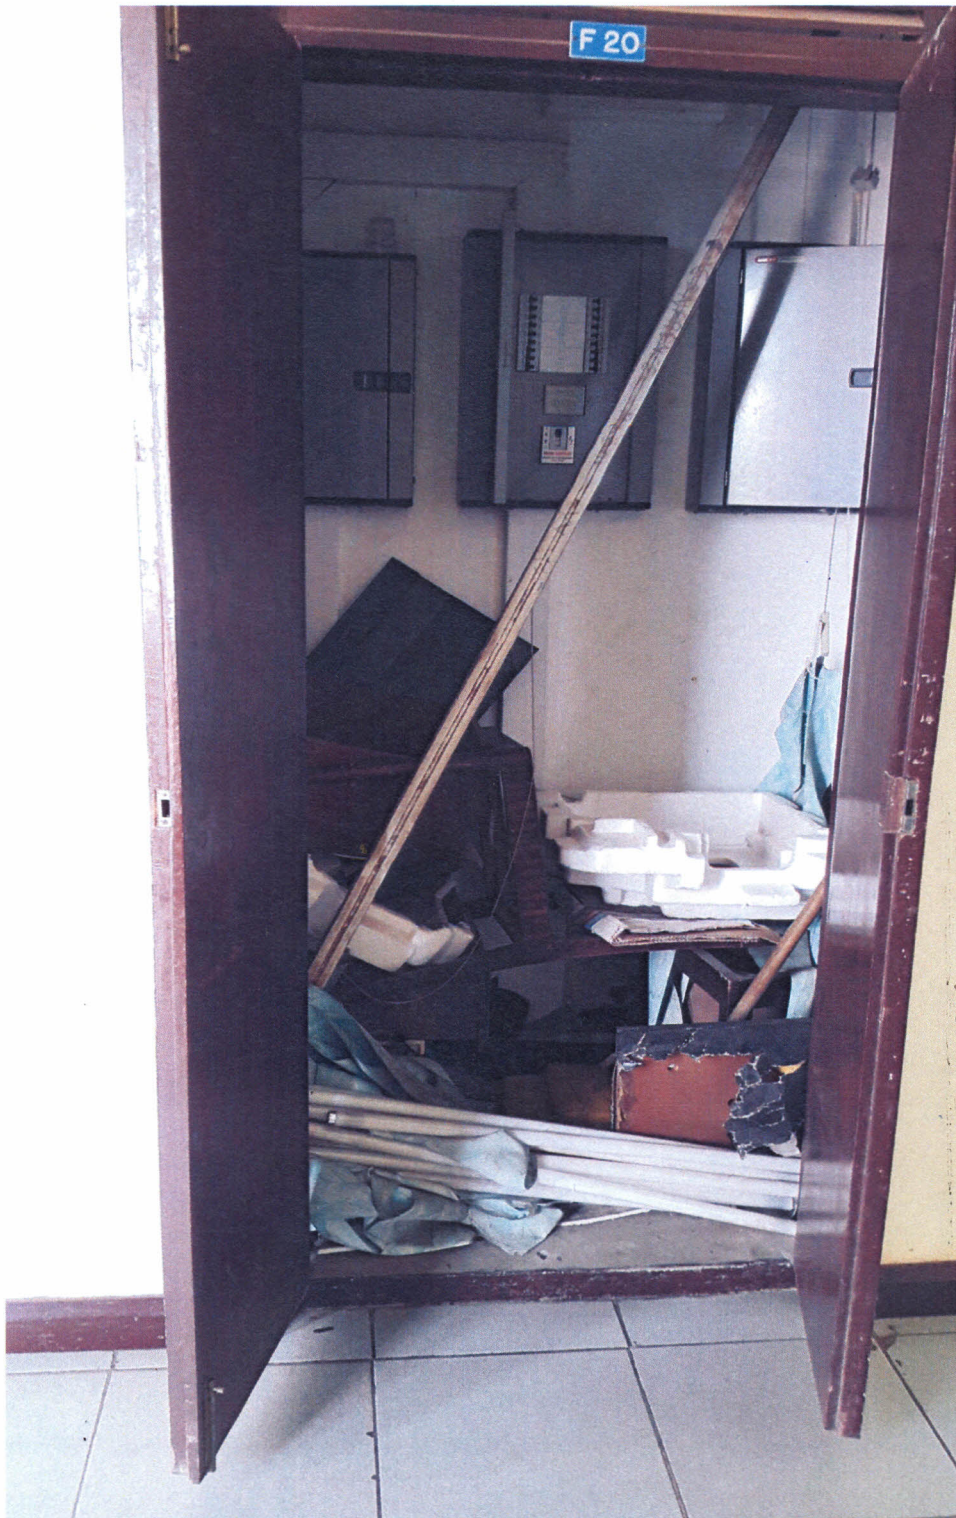
**Fig. 8. Another Picture Showing Electrical Switch Cupboards Being Used As Storage of Potentially Flammable Material**

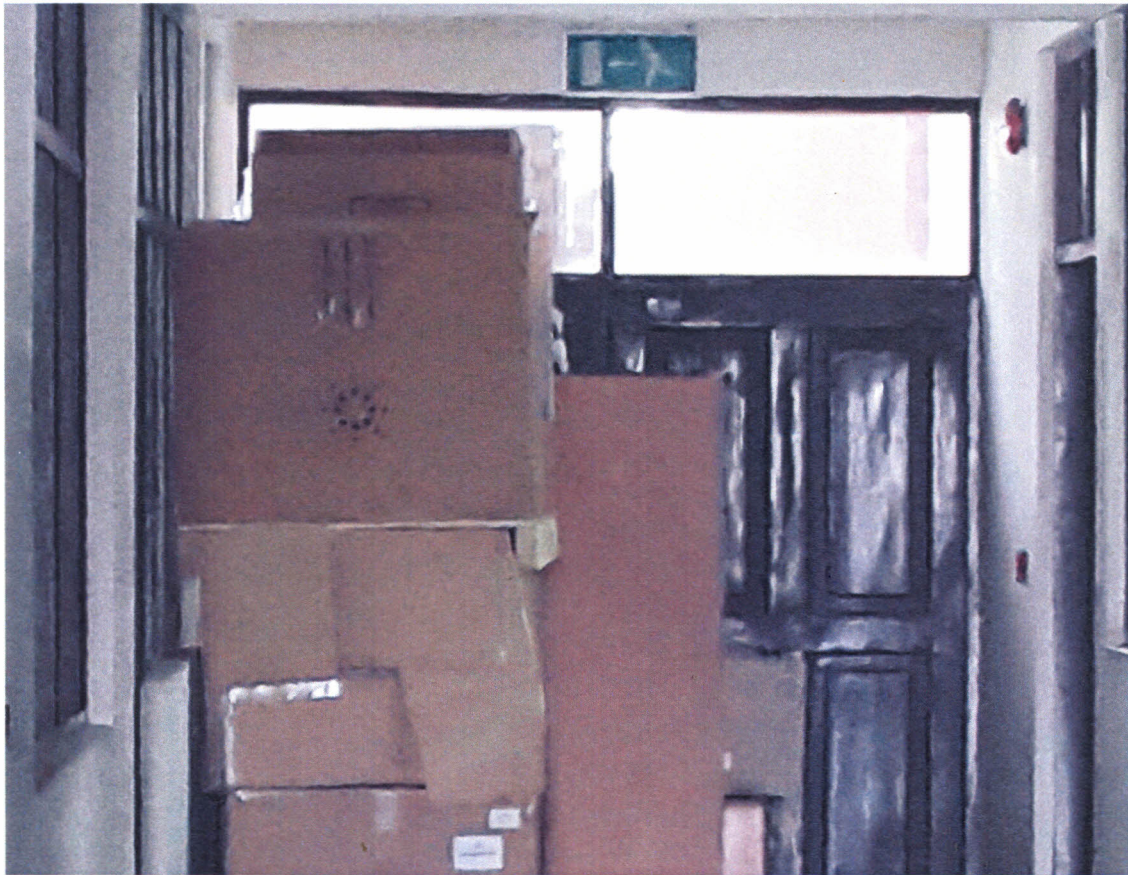
Fig. 8 A Picture Showing One Of The Fire Exits Blocked With Cardboard Boxes
